# TECHTIPS

MOTORCYCLE

AUGUST 2000

M100-042

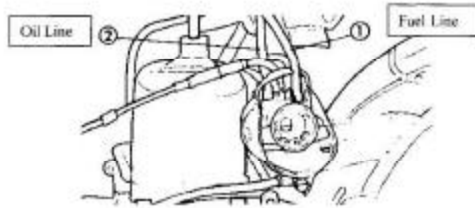
The CW50 oil tank gravity feeds 2-cycle oil to the oil pump. The line from the pump is a small diameter (3.5mm ID) tube and connects to a brass fitting on the body of the carburetor. Inside the fitting is a small spring and a steel ball that prevents the oil from being forced backwards up the tube and stops the feed when the engine is shut off.

Occasionally, the light spring pressure can be overcome by the weight of the oil in the oil tank or the steel ball valve may not be fully seated and the customer may complain of excessive smoking during cold starting after parking overnight or if the CW50 has been parked for a few days, the unit may not start at all.

A technician inspecting the problem may find an excess of oil in the float bowl where the fuel has been displaced.

It is possible to correct the problem by carefully removing the brass fitting from the carburetor, separating the (brass fitting) valve halves (they are lightly pressed together), cleaning the valve and confirming the free length of the spring is 10-11mm.

Alternatively, you may wish to remove the check ball and spring, reinstall the empty fitting. (Or you may install a nozzle, part number 824-13552-00-00). Then cut the line (2) between the carburetor and the oil pump and install an "in-line" check valve.

A suitable check valve is available from Yamaha, Part Number 6R3-13183-00-00 and will prevent the oil from leaking into the carburetor. When installing a check valve, be sure that the direction of flow through the valve is correct or severe engine damage may result. The body of the valve has a flow direction arrow moulded in it.
